# INTERIOR AND SUPPLEMENTAL RESTRAINT SYSTEM (SRS)

# INTERIOR

# SUPPLEMENTAL RESTRAINT SYSTEM (SRS)

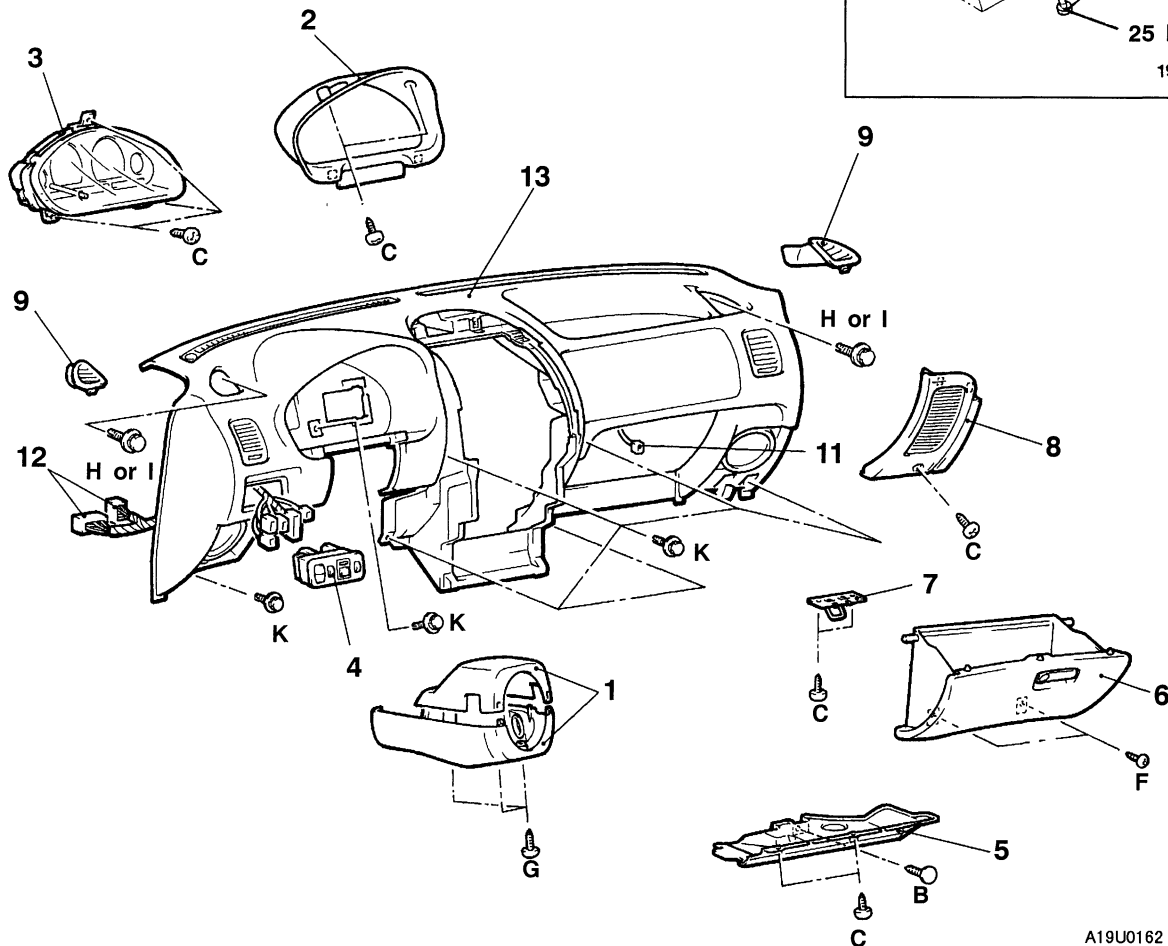
A19U0162

1. Column cover
2. Meter bezel
3. Combination meter
4. Instrument panel switch
5. Under cover
6. Glove box
7. Glove box striker
8. Corner panel
9. Side defroster grille
10. Steering column assembly installation bolts
11. Photo sensor connector
12. Harness connector
13. Instrument panel assembly

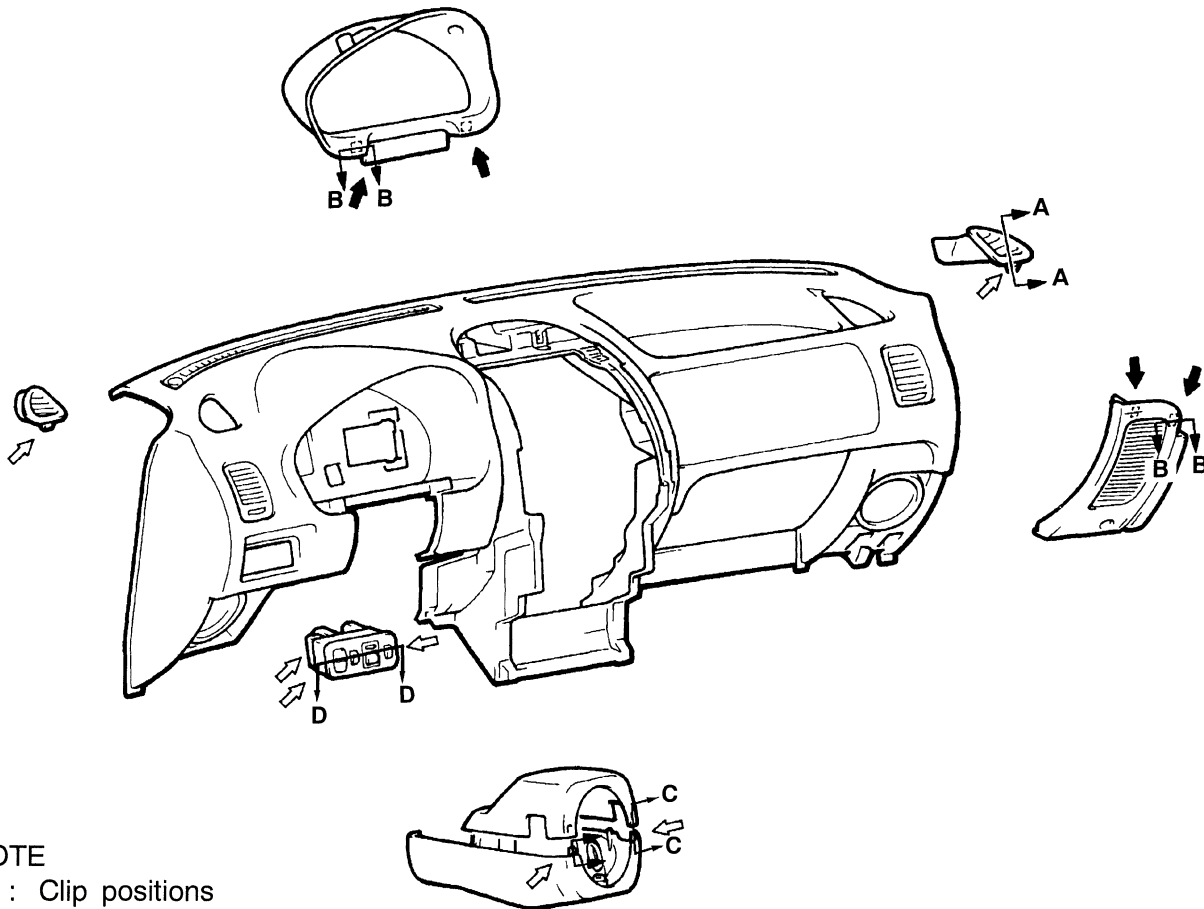
AX0024BN

- ➡ : Clip positions
- ⇨ : Claw positions

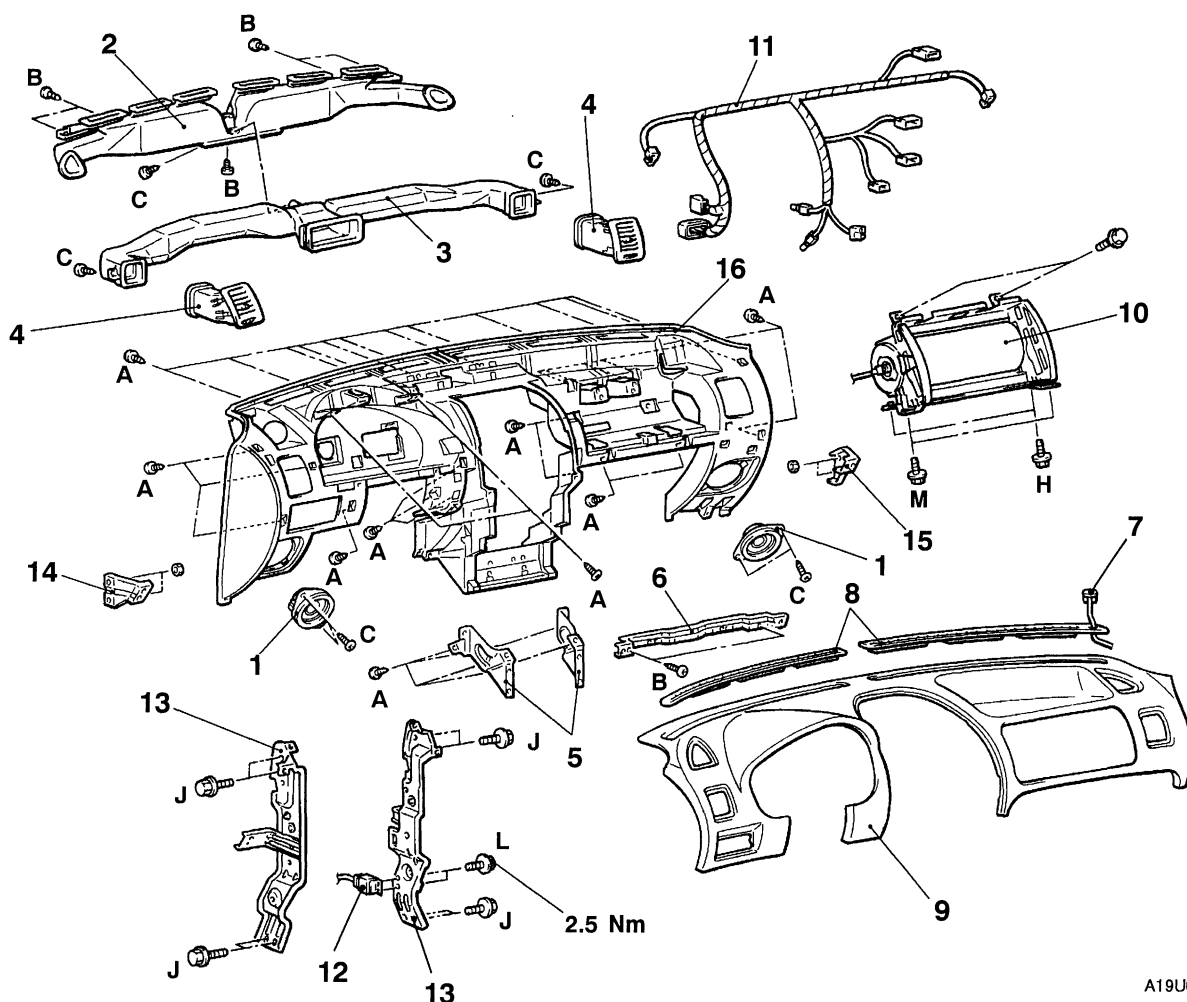
A19U0165

**Disassembly steps**

| 1. Speaker | 11. Instrument panel wiring harness |
| 2. Defroster nozzle assembly | 12. Engine control relay |
| 3. Distribution duct | 13. Center reinforcement |
| 4. Side air outlet assembly | 14. Driver's side lower bracket |
| 5. Instrument panel reinforcement | 15. Passenger's side lower bracket |
| 6. Glove box frame | 16. Instrument panel |
| 7. Photo sensor | |
| 8. Defroster garnish | |
| 9. Instrument pad | |
| 10. Front passenger's air bag module assembly | |

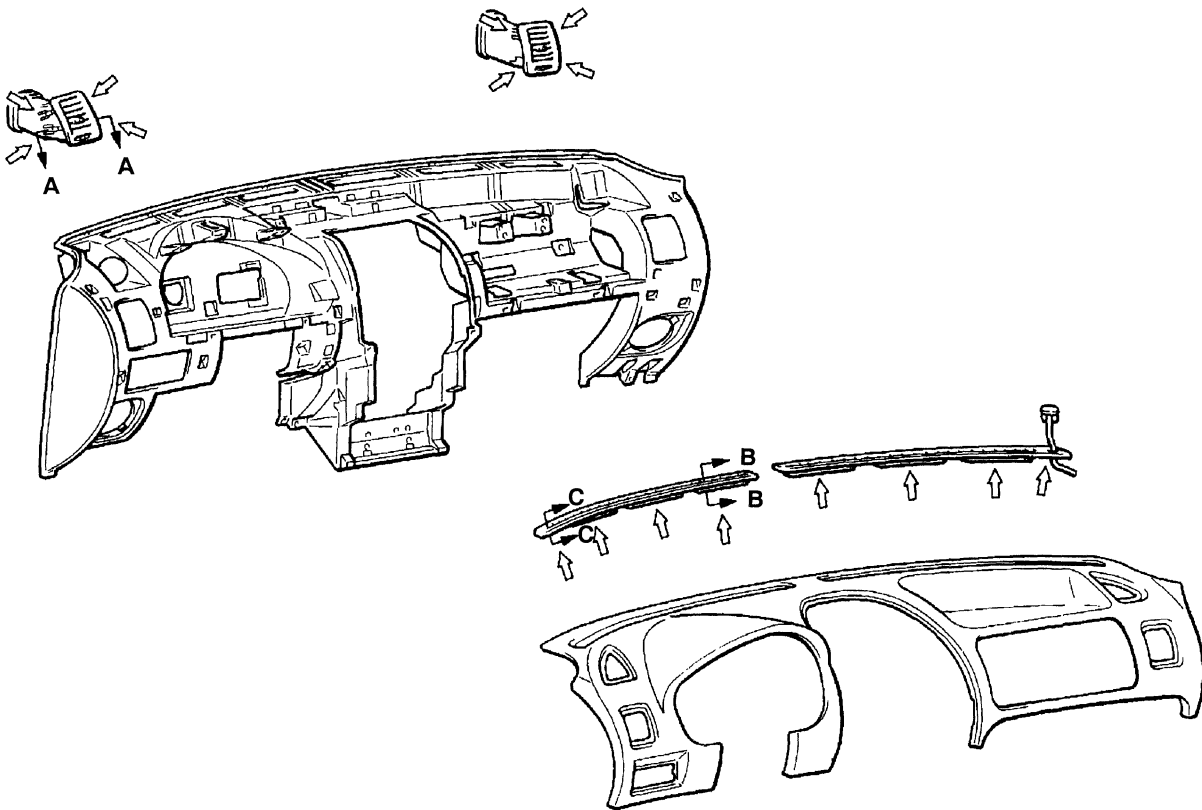
AX0025BN

⇐ : Claw positions

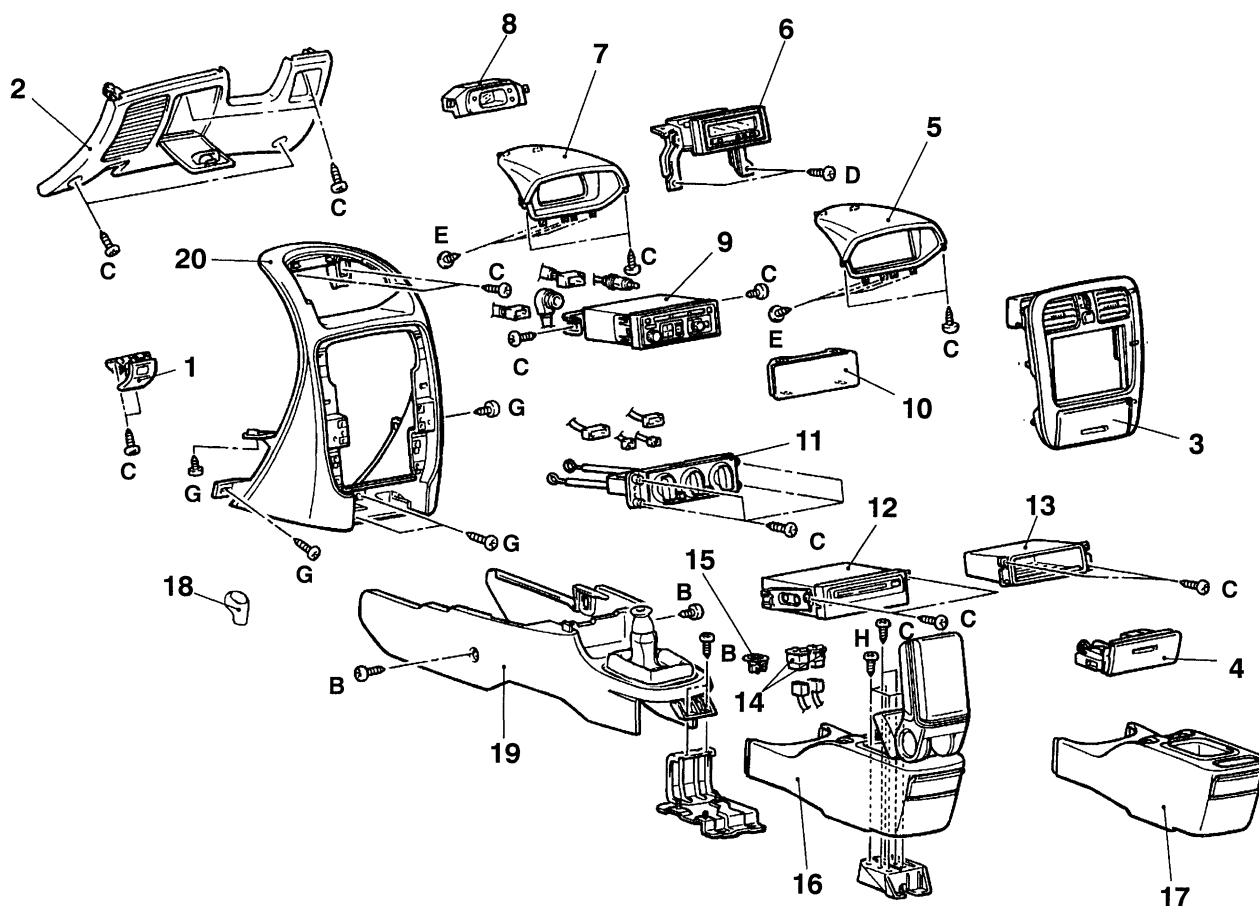
A19U0164

| 1. Hood lock release handle | 12. Navigation unit |
| 2. Instrument under cover | 13. Box |
| 3. Center panel assembly | 14. Switch |
| 4. Ashtray | 15. Coin plug |
| 5. Hood display (display) | 16. Rear floor console assembly<br>(with centre armrest) |
| 6. Display unit | 17. Rear floor console assembly<br>(without centre armrest) |
| 7. Hood display (clock) | 18. Shift lever knob <M/T><br>(Refer to GROUP 22.) |
| 8. Clock | 19. Front floor console assembly |
| 9. Radio and tape player | 20. Center console assembly |
| 10. Radio plug | |
| 11. Heater control assembly | |

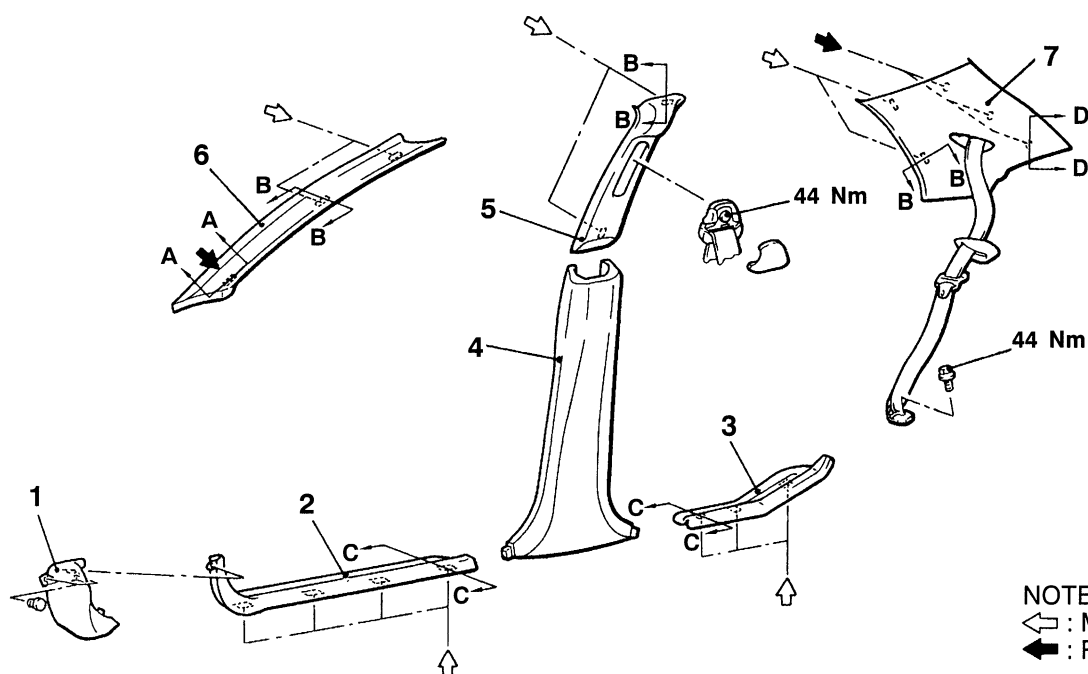
19U0097

↖ : Metal clip positions  
 ➡ : Resin clip positions

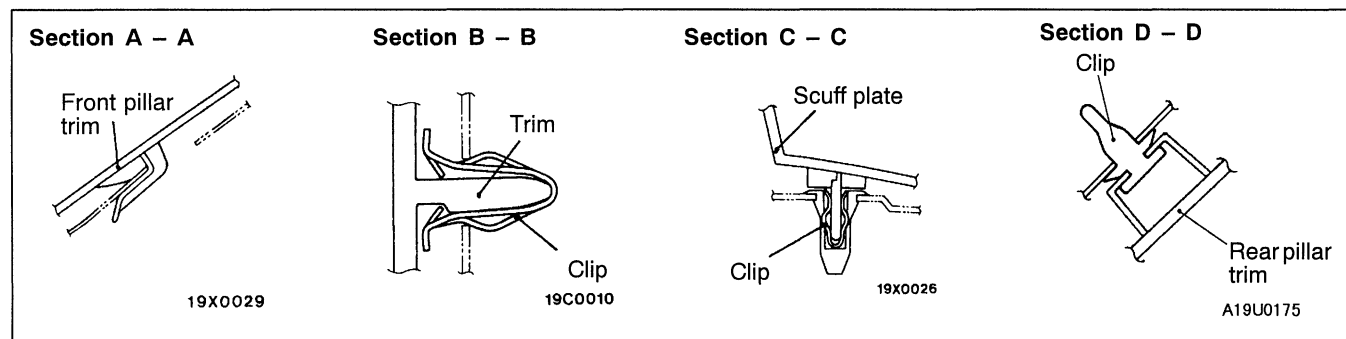
1. Cowl side trim
2. Front scuff plate
3. Rear scuff plate
4. Center pillar lower trim

5. Center pillar upper trim
6. Front pillar trim
7. Rear pillar trim

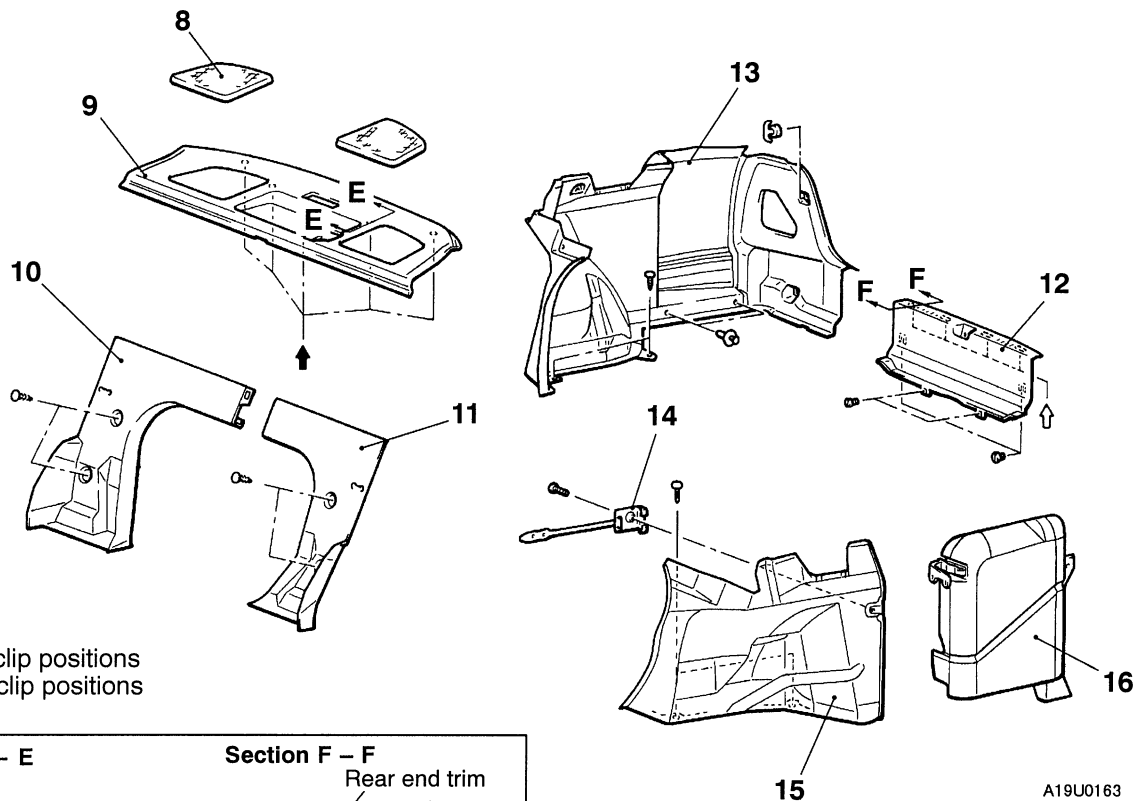
- 8. Rear speaker garnish
- 9. Rear shelf trim
- 10. Shelf front cover (RH) or trunk front trim
- 11. Shelf front cover (LH)

- 12. Rear end trim
- 13. Trunk side trim (RH)
- 14. Hook assembly
- 15. Trunk side trim (LH)
- 16. Trunk box

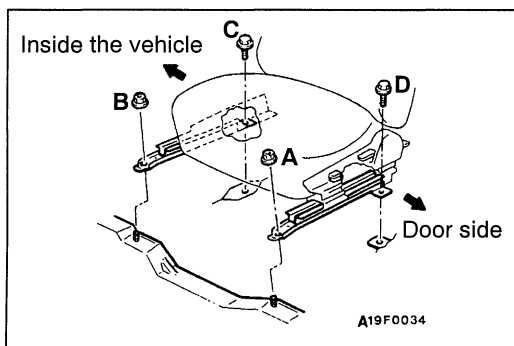
Tighten the front seat mounting bolts in the order A, B, C, and D.

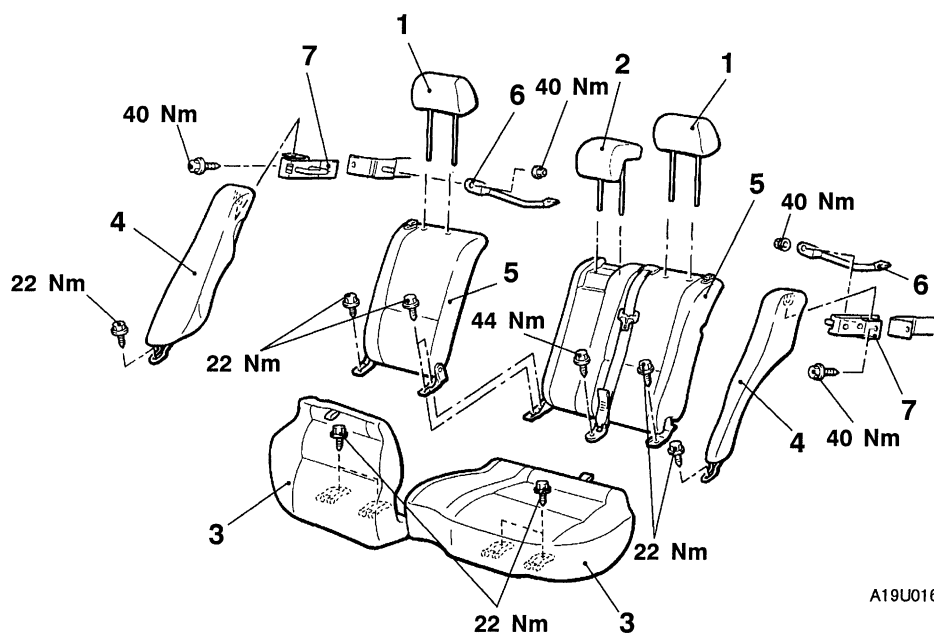
A19U0169

1. Headrest (side)
2. Headrest (centre)
3. Seat cushion
4. Side seatback assembly

5. Rear seatback assembly
6. Rear seat stabilizer
7. Rear seat striker

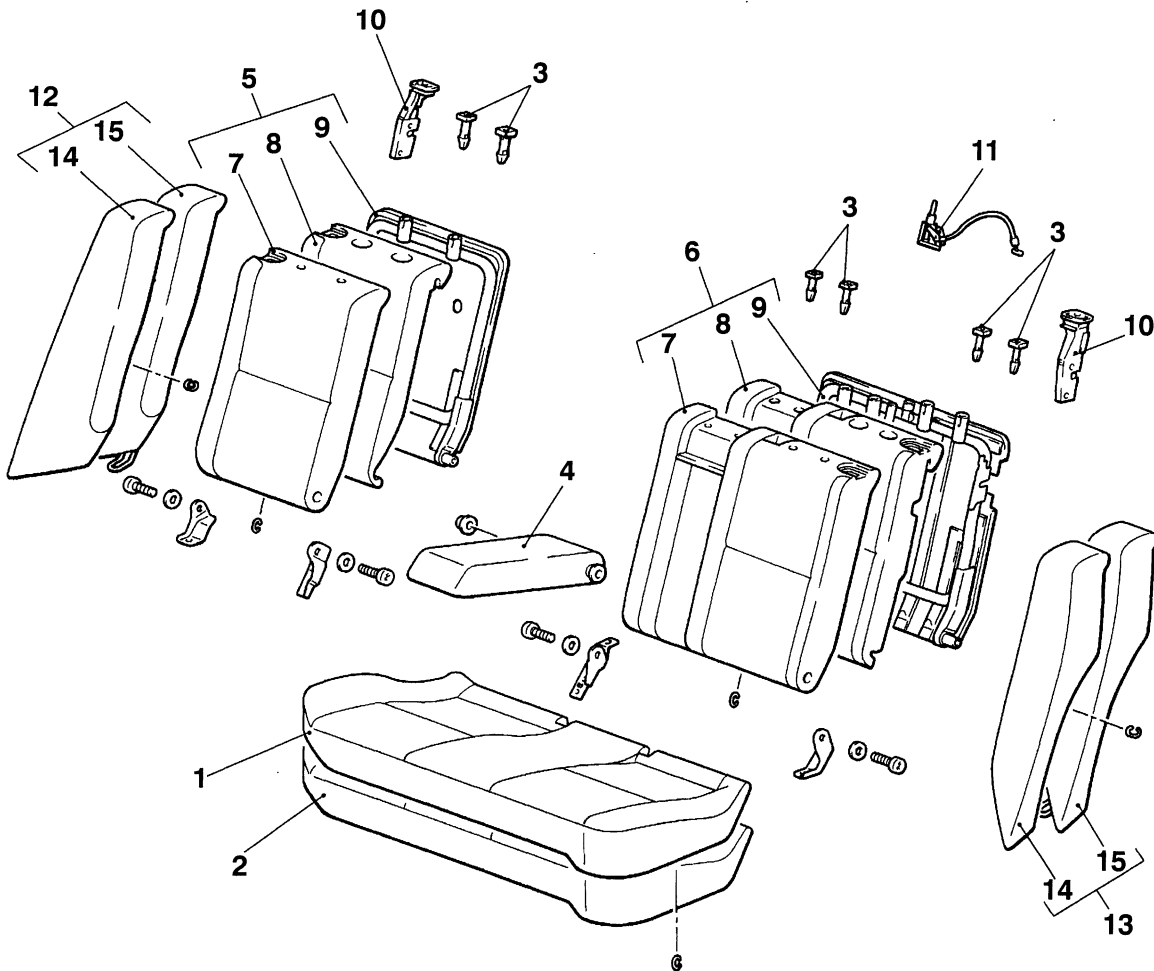
AX0074BN

1. Seat cushion cover
2. Seat cushion pad
3. Headrest guide
4. Armrest
5. Rear seatback assembly (R.H.)
6. Rear seatback assembly (L.H.)
7. Rear seatback cover
8. Rear seatback pad
9. Rear seatback frame
10. Lock assembly
11. Centre lock assembly
12. Rear side seatback assembly (R.H.)
13. Rear side seatback assembly (L.H.)
14. Rear side seatback cover
15. Rear side seatback pad

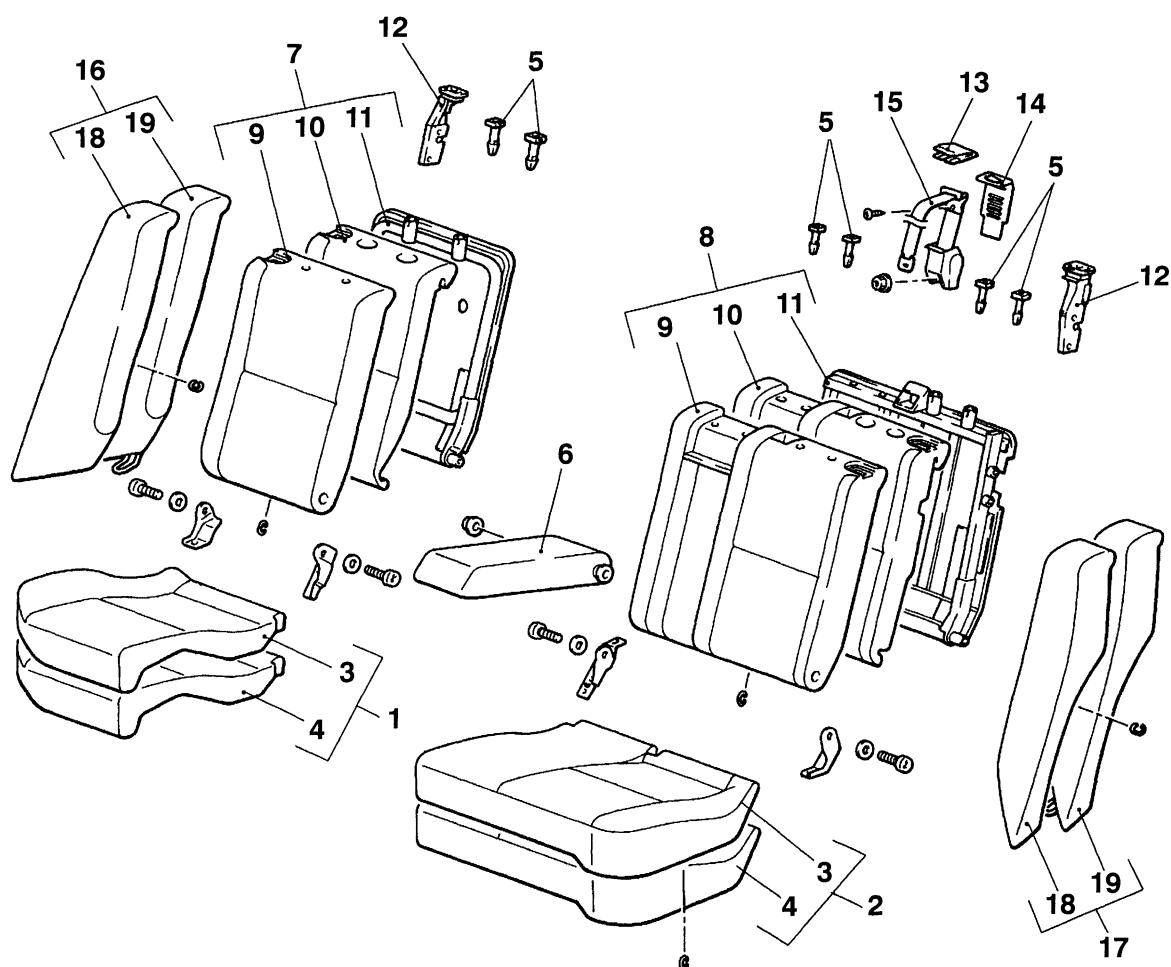
AX0073BN

1. Rear seat cushion assembly (R.H.)
2. Rear seat cushion assembly (L.H.)
3. Rear seat cushion cover
4. Rear seat cushion pad
5. Headrest guide
6. Armrest
7. Rear seatback assembly (R.H.)
8. Rear seatback assembly (L.H.)
9. Rear seatback cover
10. Rear seatback pad
11. Rear seatback frame
12. Lock assembly
13. Centre seat belt garnish
14. Centre seat belt garnish plate
15. Centre seat belt assembly
16. Rear side seatback assembly (R.H.)
17. Rear side seatback assembly (L.H.)
18. Rear side seatback cover
19. Rear side seatback pad

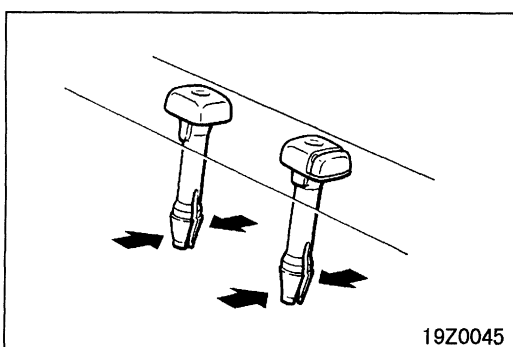
1970045

Compress the indicated portions of the guides to remove them.

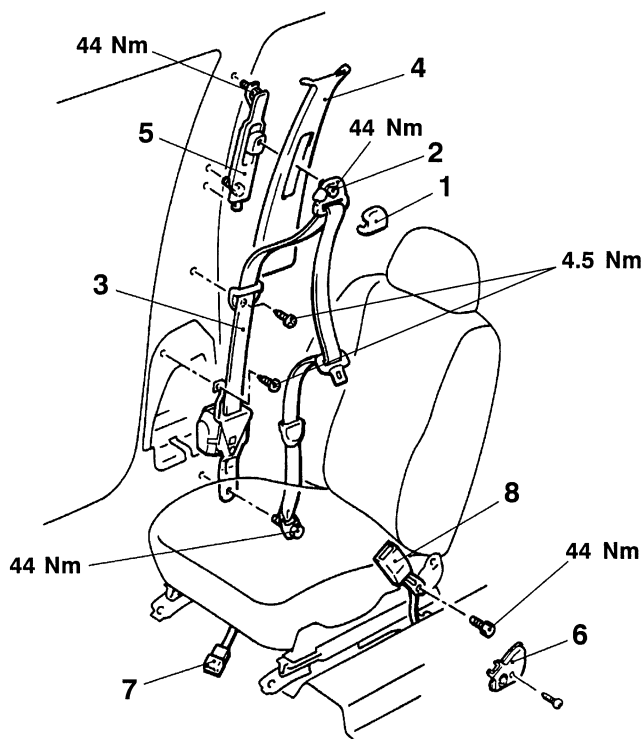
A19U0170

- Front scuff plate and rear scuff plate (Refer to P.52A-10.)
- Center pillar lower trim (Refer to P.52A-10.)
- 1. Sash guide cover
- 2. Sash guide
- 3. Outer seat belt
- 4. Center pillar upper trim (Refer to P.52A-10.)
- 5. Adjustable seat belt anchor

- Front seat assembly (Refer to P.52A-12.)
- 6. Front seat hinge cover
- 7. Buckle harness
- 8. Inner seat belt

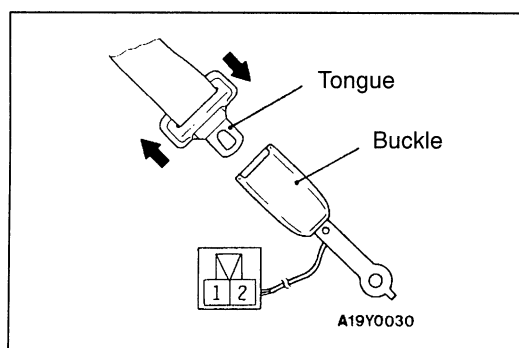
#### Inner seat belt removal steps

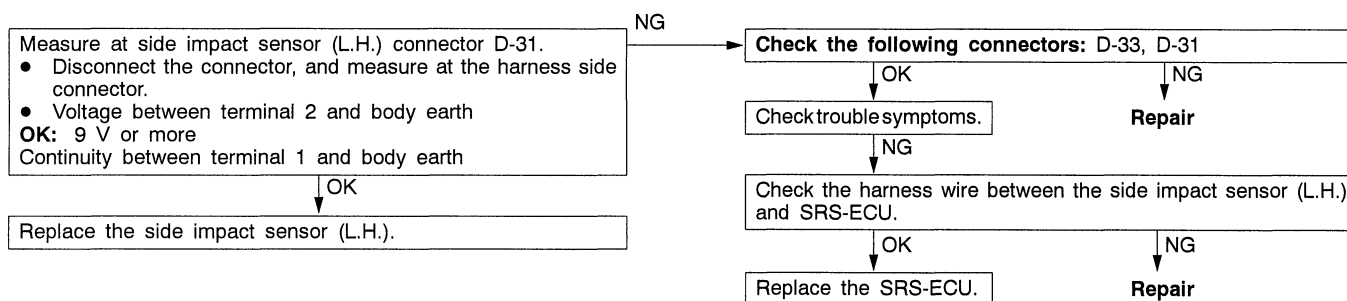
Code No.91 Side impact sensor (L.H.) power supply circuit system	Probable cause
This diagnosis code is output if the power supply voltage of the side impact sensor (L.H.) drops below the rated value for a continuous period of 5 seconds or more. However, code No.91 will be automatically cleared and the SRS warning lamp will switch off if the condition returns to normal.	<ul style="list-style-type: none"> <li>• Malfunction of wiring harnesses or connectors</li> <li>• Malfunction of side impact sensor (L.H.)</li> <li>• Malfunction of SRS-ECU</li> </ul>

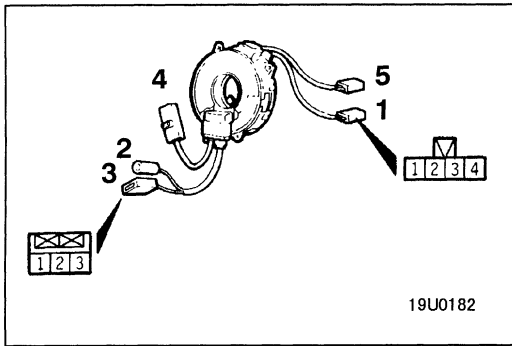
3. Check for continuity between the No. 1 connector of the clock spring and connectors No. 2 and 3.

Connector No.	1				2	3		
Terminal No.	1	2	3	4	1	1	2	3
Continuity between terminals			○		○			
	○			○		○		
		○						○
