# SERVICE BULLETIN

<b>SERVICE BULLETIN</b>		No.: ESB-99E42-504																					
		Date: 1999-11-15	<Model> (EC,EXP) CARISMA <M/Y> 98-10																				
Subject: CORRECTION TO CENTER DOOR LOCK TROUBLESHOOTING																							
Group: BODY																							
CORRECTION	  O. Kai - E.V.P. & G.M. After Sales Service Dept.																						
<b>1. Description:</b> This Service Bulletin informs you that typographical errors in the center door lock troubleshooting have been rectified.																							
<b>2. Applicable Manuals:</b>

## Inspection Procedure 13

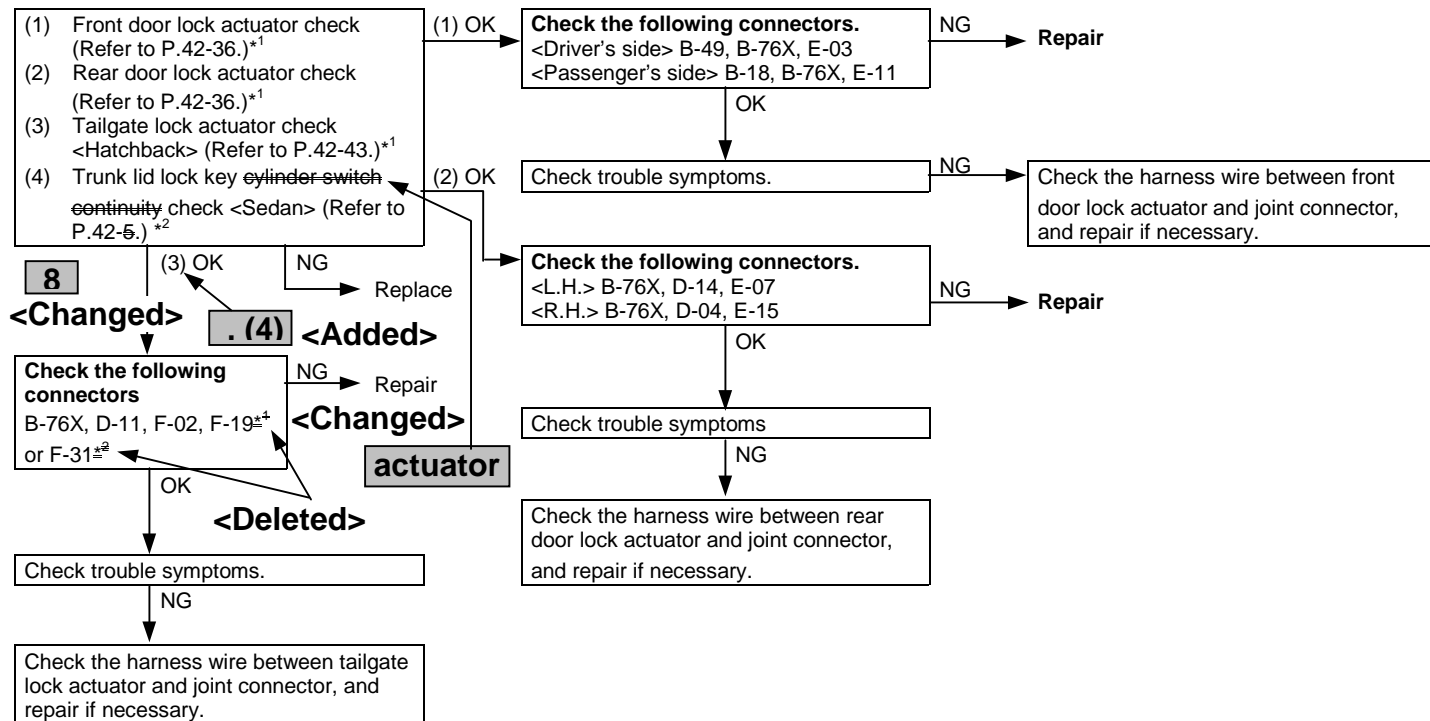
Some doors do not lock or unlock	Probable cause
The door lock actuator, a harness or connector may be defective.	<ul style="list-style-type: none"> <li>Malfunction of the door lock actuator</li> <li>Malfunction of the wiring harness or connector</li> </ul>
